### LONG PRODUCTS BUSINESS – THRYBERGH BAR MILL

#### Failure of 20mm wire rope sling

#### (General Engineering Ropes – Flemish Eye design)

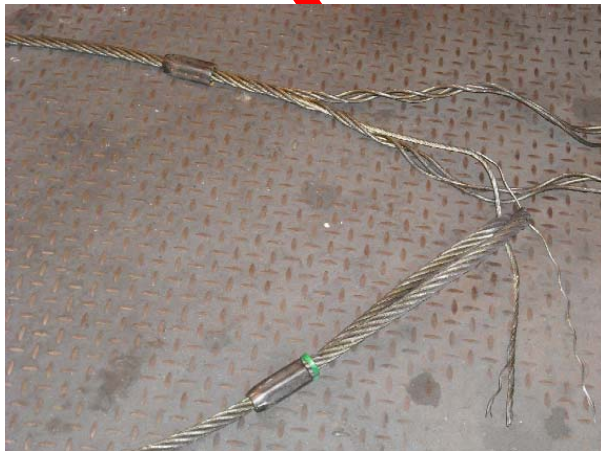
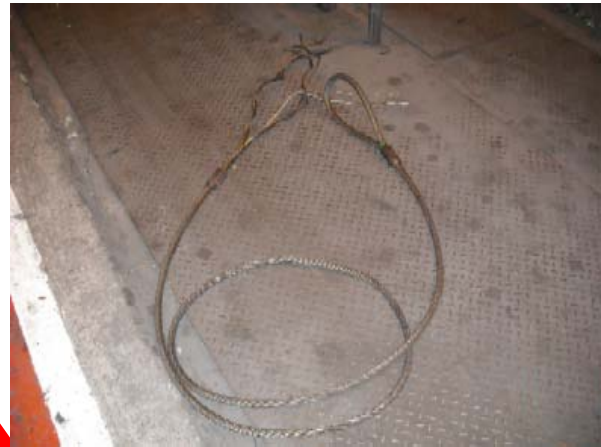
On the 15<sup>th</sup> June three bundles of round bar material weighing 13.360 tonnes, were in the process of being lifted. The bundles were correctly slung by two steel spiral wound wire ropes manufactured and supplied by Certex using the basket method and attached to a specific lifting beam. The lift was well within the Safe Working Load of 20.00 tonnes. When the lift had reached a height of approximately 10 feet the loop on one end of the rope unwound and pulled free from the ferrule causing the bundles to fall to the floor.

- There have been two significant failures of the 20mm wire rope sling
- Both slings were manufactured by the same company, Certex
- Both slings were from the same batch number (35485 – 1701)
- Both slings failed whilst carrying out the same task
- Both slings failed after carrying out less than 200 lifts
- The second sling failed even though it had been proof tested as part of the first investigation
- No injuries were sustained - safe by position

- Extensive testing by Certex identified situations in which the loop of the Flemish eye can pull out when the following criteria occur during the manufacturing process:
  - The loop is formed with short tails which do not fully insert into the ferrule
  - The rope diameter is at the bottom of its manufactured tolerance, 20mm +5% -0%
- Certex proved that with full length tails and the core inserted that this type of failure cannot be replicated independent of the rope diameter, (within tolerance)
- Certex are in the process of modifying their manufacturing and quality assurance systems to ensure these new procedures are adopted.
- Certex have also identified this issue may be prevalent in sizes, 12, 20, 24, 30 and 36mm diameter Flemish eye slings all of which are manufactured in an identical way

- All 20mm slings removed from service – pending tests
- Interim size upgrade of slings to 22mm

- All business units should, with immediate effect, remove from service all Certex manufactured 20mm Flemish eye slings
- All business units should review the use of all Certex manufactured Flemish eye slings in the following sizes, 12, 24, 30 and 36mm diameter and contact Certex immediately for further advice
- Anyone using Flemish eye slings from sources other than Certex should contact their respective supplier to ensure that these manufacturing issues are not in existence.
- Once again re - iterate safe by position for all lifting operations
