Safety Alert

Catastrophic Rope Failure

An incident occurred on one of our sites recently involving a mobile crane and a catastrophic failure of a 3tonne single hoist (wire rope) during the lifting of a precast slab.

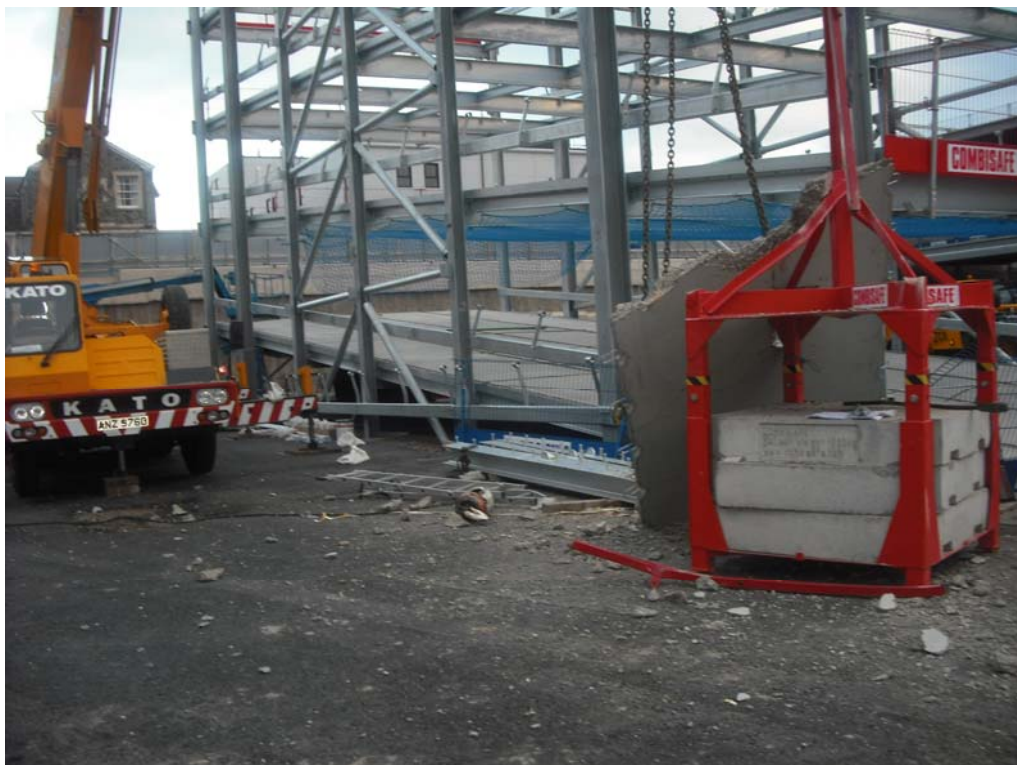
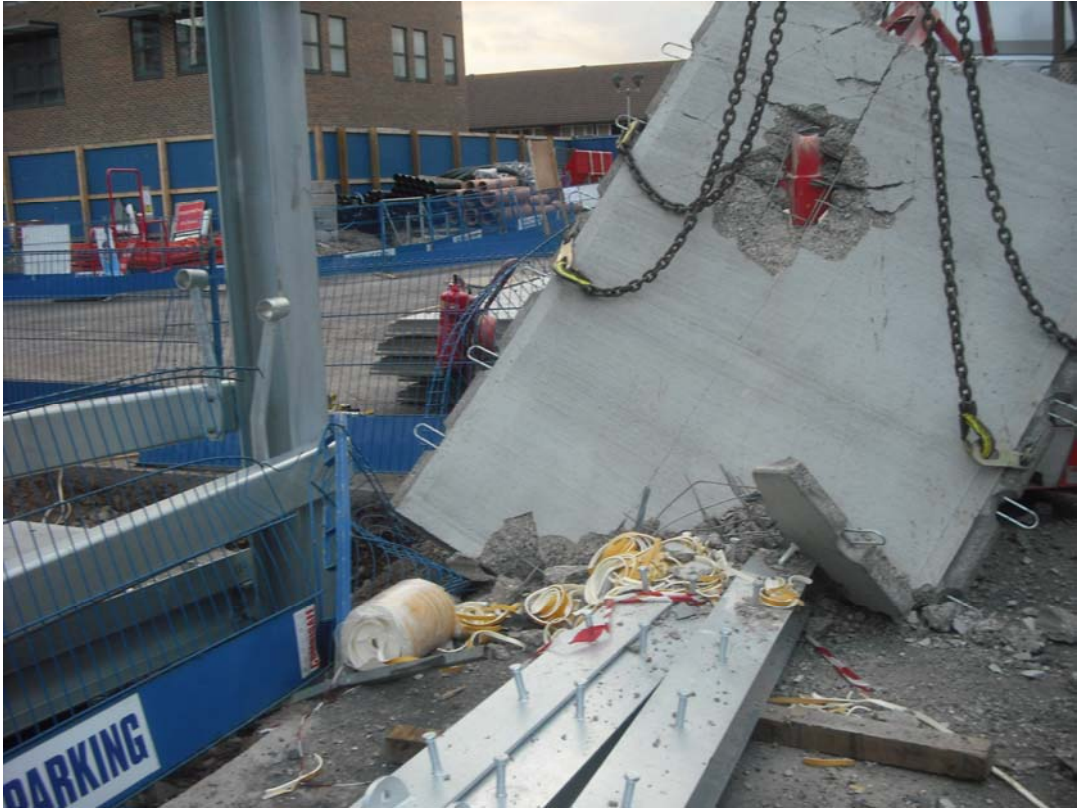
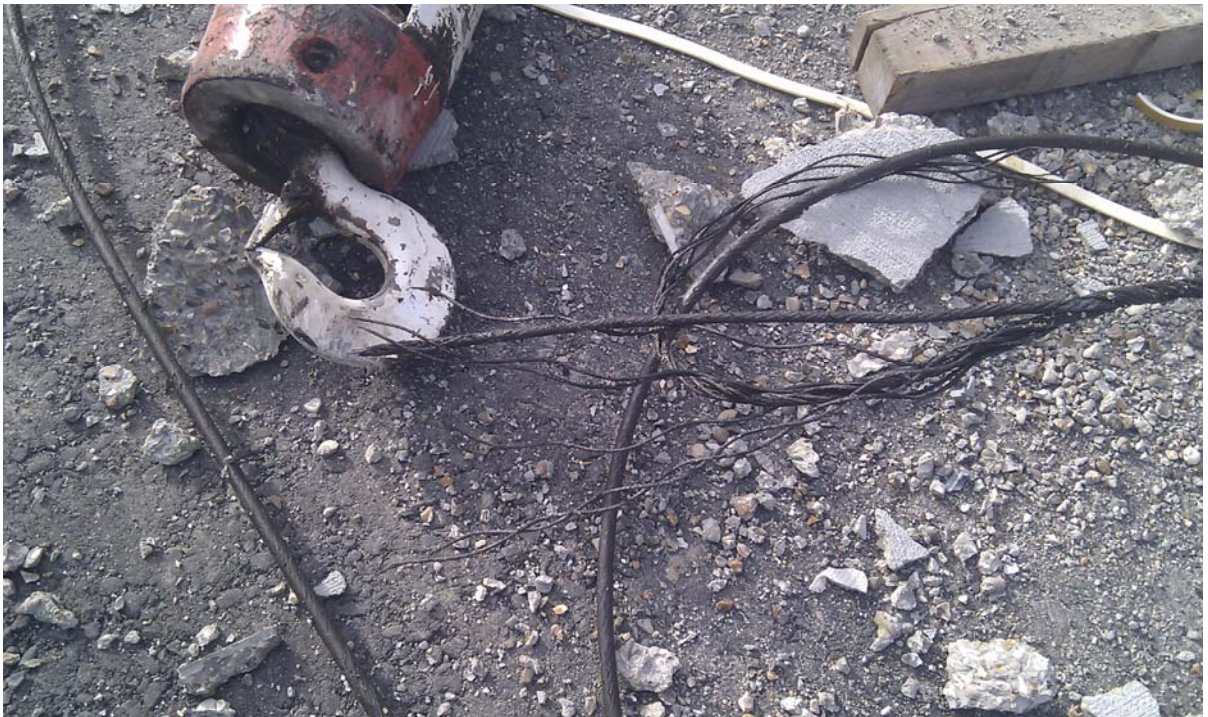
Slabs were being off-loaded from the flat bed lorry on to the ground by a Kato mobile crane, using a 3t hoist, lifting a weight of 2.5t (within the SWL). This operation had been going on all day (over 20 lifts had taken place). A slab had been hoisted and was being slewed from the wagon to the lay down area when the hoist rope snapped (approximately 7mtrs from hook). The slab fell 4mtrs to the ground hitting the combi-safe fail arrest arm/system.

As a part of the investigation the wire rope was inspected by an expert who concluded that the cause of failure was due to heavy wear which had locally reduced the cross section periodically along the wires. In some cases there was less than half the original thickness remaining. The failure may also have been exacerbated by others factors such as hydrogen effects, fatigue and/or abuse of the wire at some stage in the past.

Site Managers/staff are therefore requested to check/complete the following against each of the cranes on their site (client cranes excluded but please pass message on):

1	Check all crane documentation	Compliant / Comments
	1a. Thorough examination certificate (latest date)	
	1b. Weekly crane inspection log	
	1c. Age of crane (Year of Manufacture) & Serial No	
	1d. Age of the rope(s)	
	1e. Is there a clear history of the use/maintenance of the crane since YoM	
2	Crane Operative (competent person) to visually check wire rope before commencing next lift (check for excessive wear, broken strands, any deterioration which leads to significant risks).

If any rope wear/deterioration is apparent the crane must be quarantined and a thorough examination test administered immediately.
