SAFETY ALERT

Scalding Accident to Plant Operator

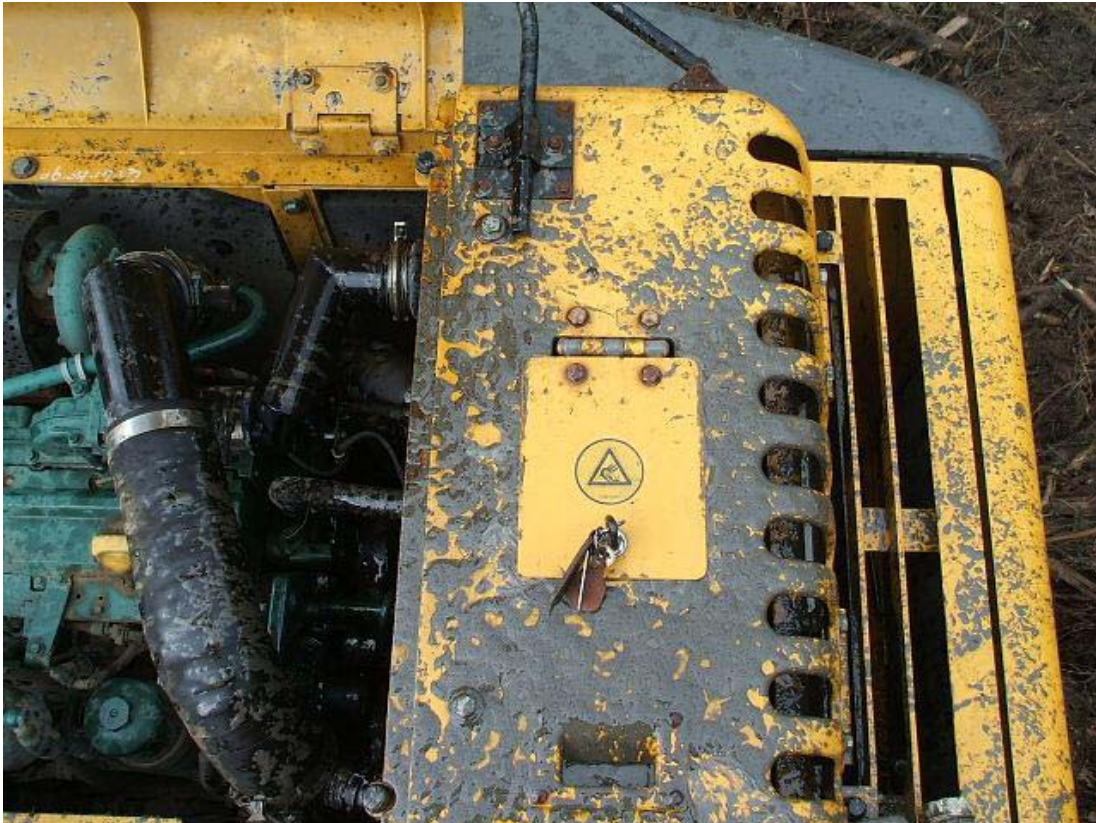
Injured Person was operating his 18Ton excavator when the machine started to overheat.

Injured Person stopped the machine and proceeded to inspect the engine bay.

Injured Person walked to the compartments on the side of the machine and removed two water bottles with spare water for topping up the radiator.

Injured Person then walked on the top of the machine, and unlocked, using the ignition key, the radiator cap cover.

Injured Person started to undo the radiator cap.

The cap was under pressure, and blew off, throwing hot liquid (of exact type remains to be identified) burning Injured Persons face and body.

**IF THE DISPLAY ON YOUR MACHINE DISPLAYS AN
OVERHEATING WARNING:**

**THEN STOP THE MACHINE, ALLOW IT TO COOL
BEFORE FURTHER INVESTIGATION AND THEN
MAKE THE SITE MANAGER AWARE OF THE
PROBLEM.**

FOLLOW THE MANUFACTURERS INSTRUCTIONS.
